**REHAU MONTANA ECOSMART HOUSE PROJECT
Bozeman, MT
RMEH 05 Test Report**

**Evaluation of Temperature Stratification in Room with
Cathedral Ceiling:
Radiant Floor Heating vs. Forced Air**

**F. Javier Alvarez, LEED GA
Kevin Amende, P.E.
Mechanical and Industrial Engineering Department
Montana State University
05/15/2015**

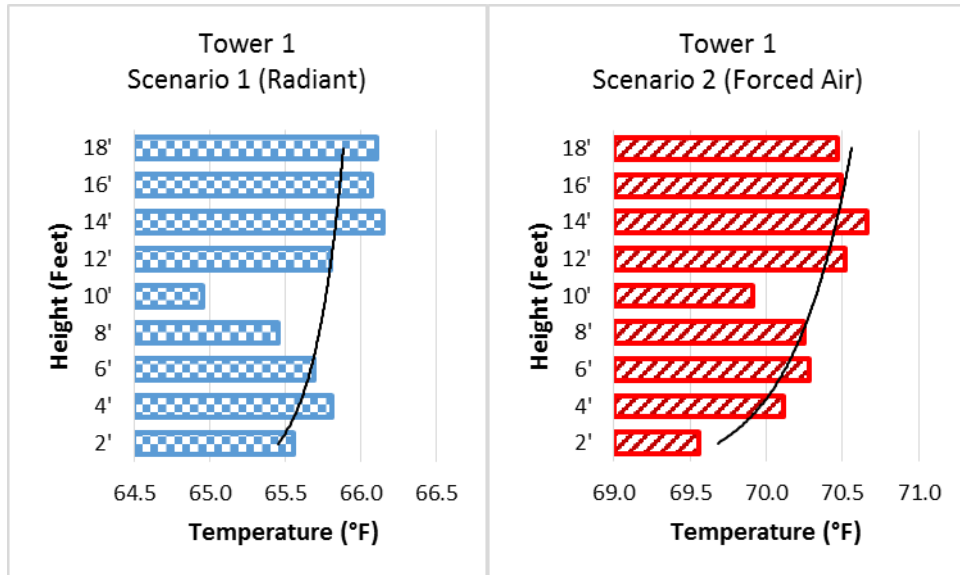
Figure 4. Stratification Study of Tower 1. Temperatures were averaged over the last 36 hours of the experiment. A logarithmic trend line is shown in the graph.

During the radiant floor portion of the test, no significant vertical stratification was observed. Temperature difference between sensors at 2-feet and 18-feet height was never greater than 0.5°F in tower 1, whereas in towers 3 and 4, the temperature difference was practically nonexistent (see Figure 4, Figure 5, Figure 6 and Figure 7). This is interesting since the natural tendency of warm air is to rise. However, the warm slab is continuously providing heat from the floor thus counteracting that natural tendency all across the vertical section of the room.

On the other hand, during the forced air portion of the test, stratification was more apparent. Overall, the temperature difference between sensors at 2-feet and 18-feet height ranged between 0.8°F and 1.1°F during the test. It is also interesting to observe that there was a decrease in temperature from 16-feet to 18-feet height, probably because of the inner surface of the exposed roof being cooler due to the cold outside conditions. Stratification on tower 4 was the most noticeable (Figure 7), and it make sense since it was the tower having the closest floor register of the 4 tall ones (see Figure 2).

Another interesting observation was the anomaly occurred near the 8 to 10-feet height sensors on towers 1 and 2. It appears that the temperature was approximately 1°F less than what would have been expected from the natural trending of the other sensors. One possible explanation could be that fact that towers 1 and 2 were placed near by the upstairs hallway (see Figure 12), and this could have affected the temperature of the sensors close to the upstairs floor, which was not being heated during the course of the experiment.

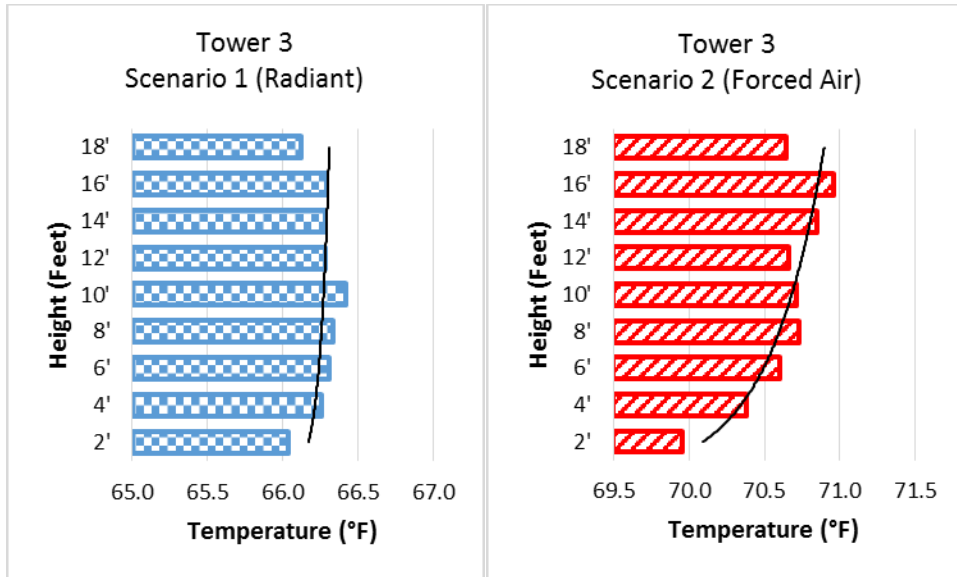
Figure 6. Stratification Study of Tower 3. Temperatures were averaged over the last 36 hours of the experiment. A logarithmic trend line is shown in the graph.

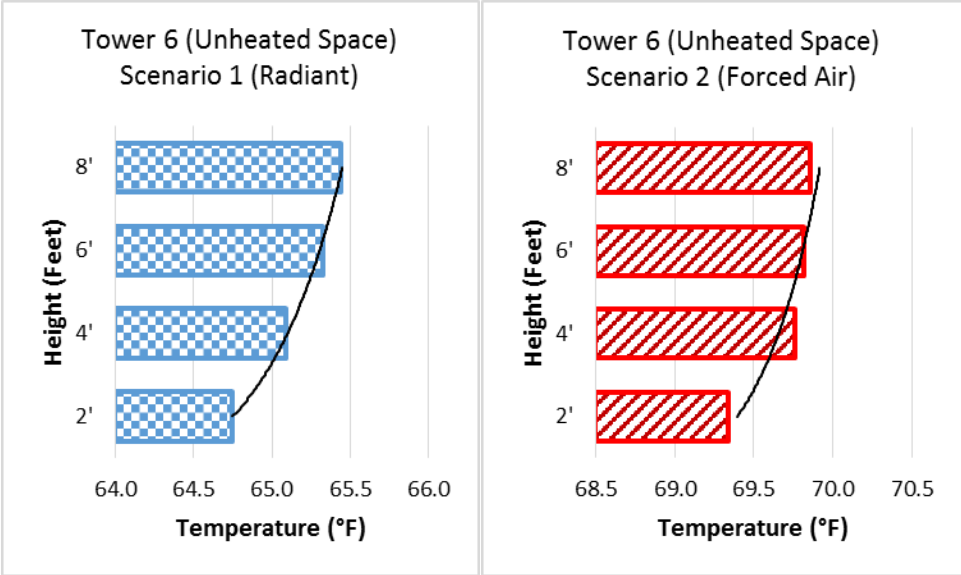
Figure 9. Stratification Study of Tower 6. Temperatures were averaged over the last 36 hours of the experiment. A logarithmic trend line is shown in the graph.

The two short towers showed no relevant vertical stratification occurring during the experiment. Tower 5 was placed in the kitchen (Figure 2), and the average temperature over the last 36 hours showed no significant difference between the radiant floor and forced air scenarios (see Figure 8). Tower 6 was placed on a transition space between the end of the front entry hallway and the stairway (Figure 2). It could be noticed from the data that the floor on that area did not heat up during the radiant floor scenario, thus that tower cannot be considered for this experiment since it was placed on an unheated spot. However, it is interesting to see how the temperature indeed stratified when the slab was not active (see Figure 9), supporting the observation made before of the warm slab counteracting the natural stratification.

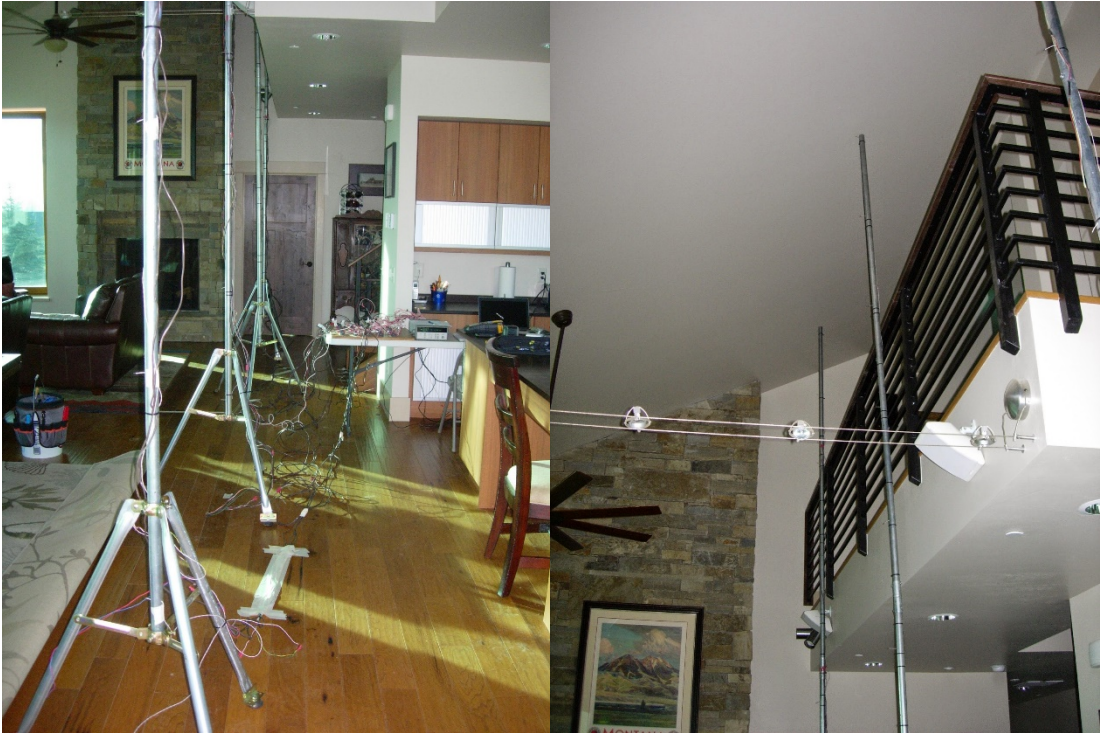
Figure 12. 18-foot tall towers on living/dining area

The purpose of this experiment was to evaluate the temperature stratification from floor to ceiling comparing radiant floor heating with forced air based system in room with cathedral ceiling. Dry bulb temperatures were measured every 2-feet in six different towers, four of which were 18-ft tall and two were 8-feet tall. The towers were located in the Living/Dining Room area on the main floor of the Ecosmart House (see Figure 2 and Figure 3). Two different scenarios were tested: radiant floor heating and traditional forced air heating. Thermostat setpoints were 68°F and 72°F respectively for each scenario. Outdoor reset schedules were in use to determine the temperature of the supply water to the radiant system, which remained within the range of 85°F to 95°F (Figure 18). Supply air temperature was set to constant 100°F (Figure 19), which is conservative compared to traditional furnace systems. Each test scenario was run from a cold start and measurements were processed over the last 36 hours, when stable temperatures were achieved in the room.

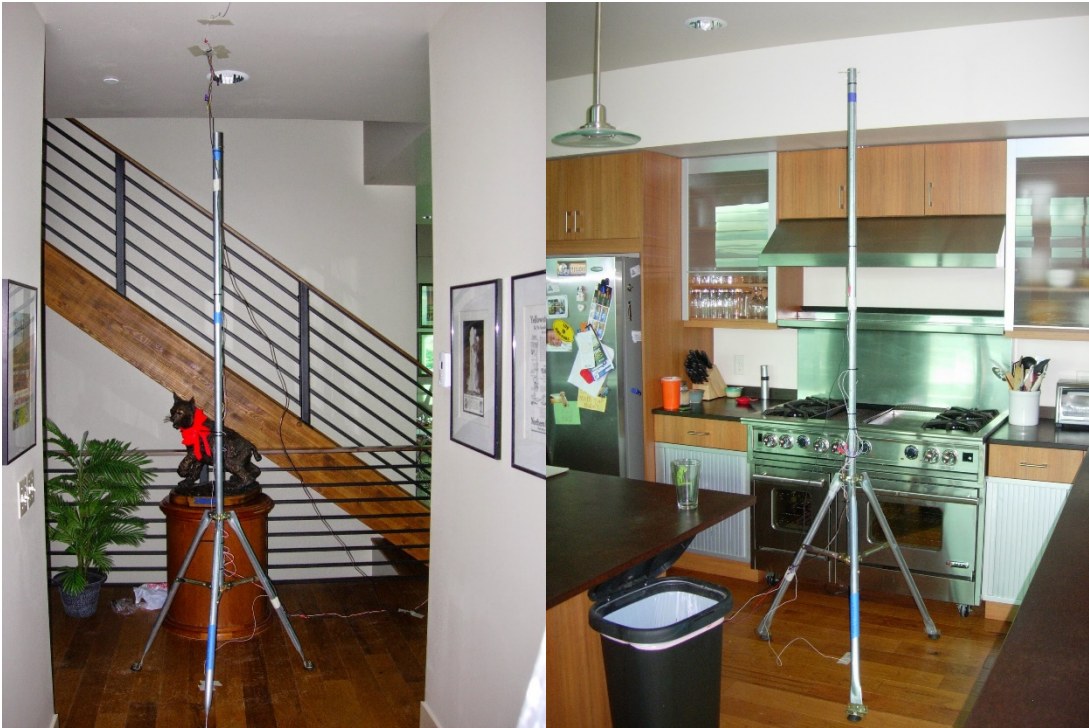
Figure 13. 8-foot tall towers on hallway and kitchen

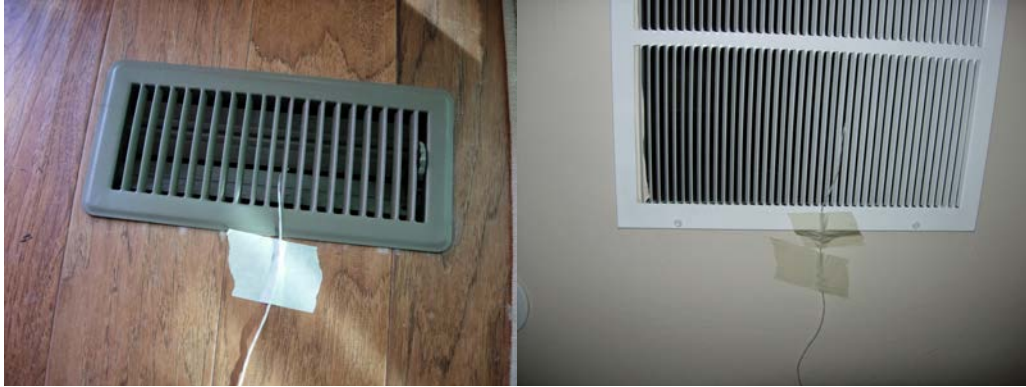
Figure 14. Temperature sensors in floor register and return grille

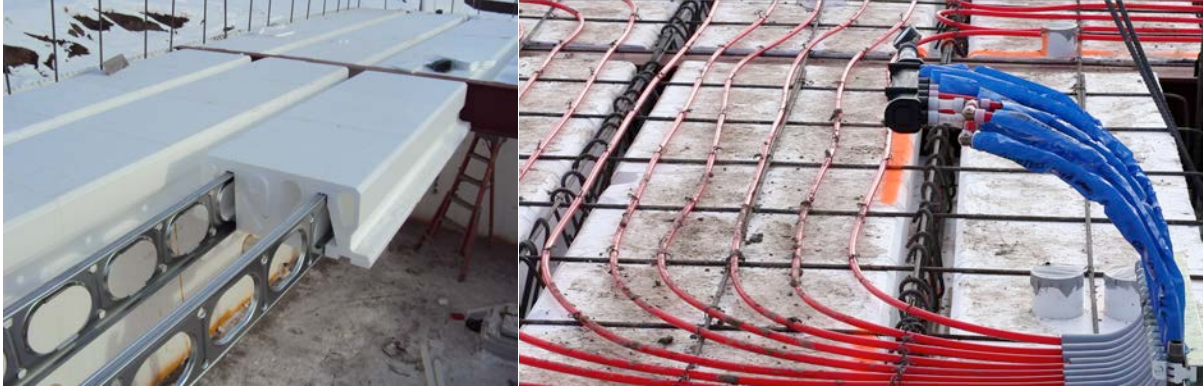
Figure 16. Different phases of the floor construction

The floor is a 12" Expanded Polystyrene (EPS) blocks deck on 1-5/8"x10" metal joist 16" OC with an over poured 3" reinforced concrete topping slab, finished with a hardwood panel. The hydronic radiant floor is embedded in the concrete and is made of 1/2" Crossed-linked Polyethylene (PEXa) pipe (see Figure 16 and Figure 17).

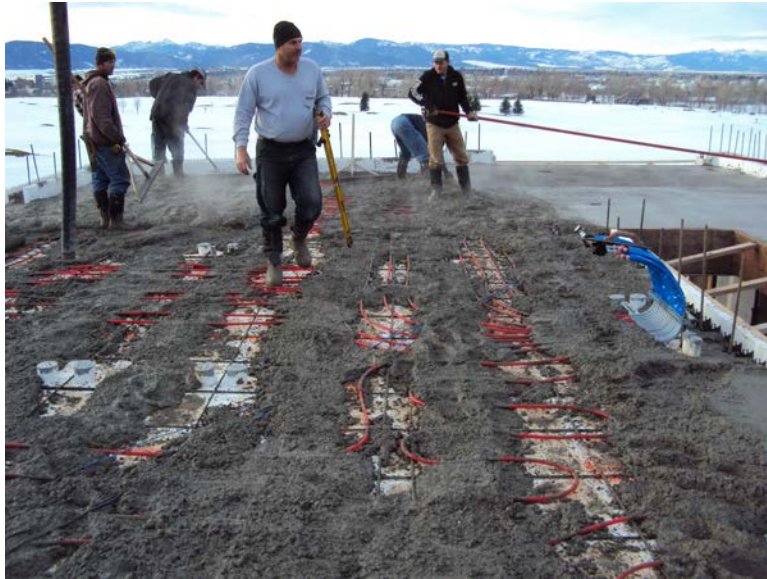
Figure 17. Over poured concrete slab with embedded 1/2" PEXa pipe

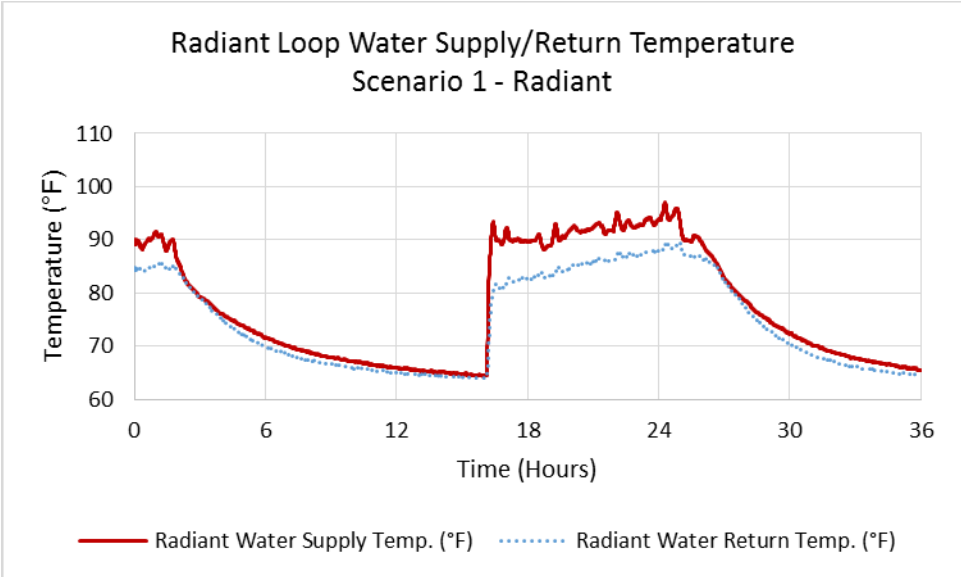
Figure 18. Radiant Loop Water Supply/Return Temperature Profile during Scenario 1 (Radiant)

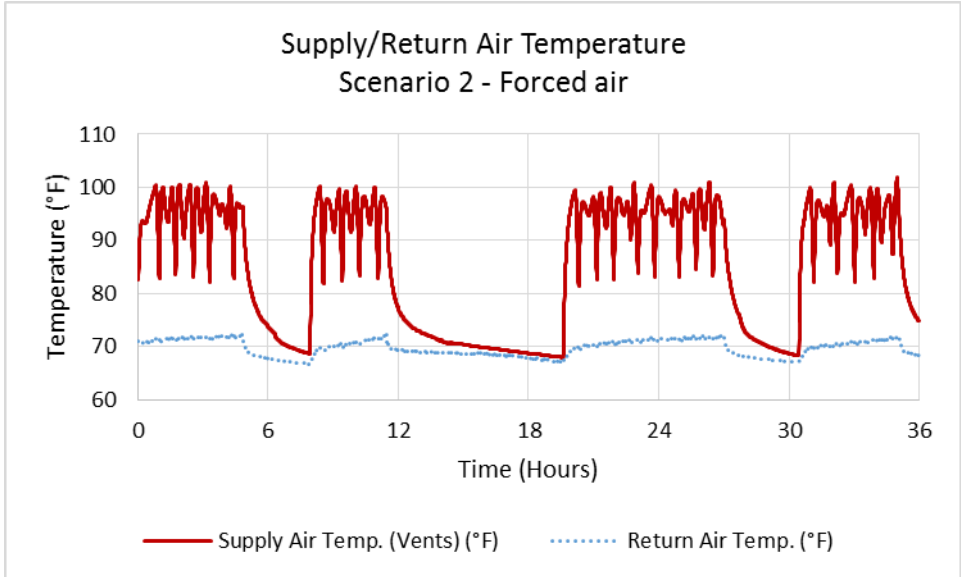
Figure 19. Supply/Return Air Temperature Profile during Scenario 2 (Forced Air)

It is important to point out that the temperature of the air supplied to the registers during the forced air scenario was around 100°F or less (Figure 19). If the test had been run with the traditional 120°F supply air temperature used in many furnace systems, the stratification during the forced air scenario would have been most likely even more pronounced.
